**MODELS**      LC26SD1EK              LC32SD1EK              LC37SD1EK              LC42SD1EK

Reference – SP071102x  
Revision - 1

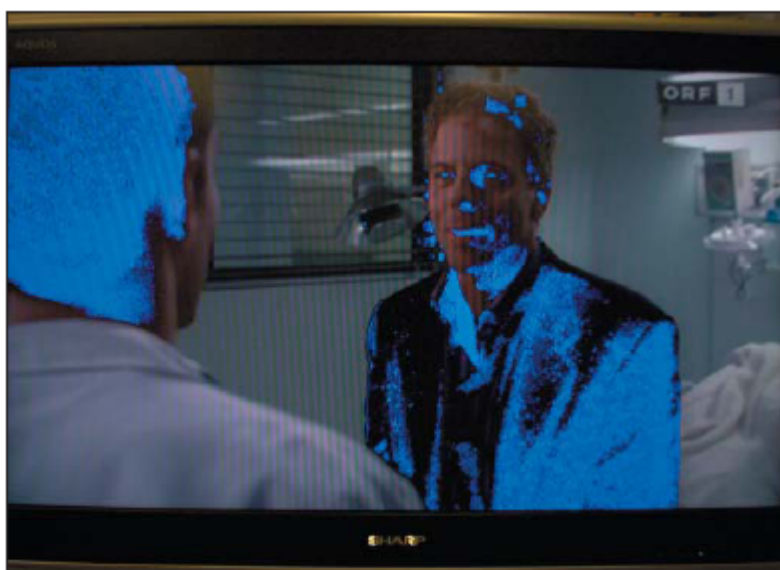
**SYMPTOM**    Coloured shadows red, green or blue.

**CAUSE**        Software issues between IC3002 VCT and IC4203.

Figure 1: Example of coloured shadows phenomenon.

**ACTION**        Update both IC3002 (Main) and IC4203 (DTV) operating software to latest versions.  
When the update is completed activate the “EEP clear B” option via the service menu.

Do Not activate “EEP Clear” (first option) under any circumstances.
